The Owner's Guide to Piano Repair

Focus On: Brass Rail Repair

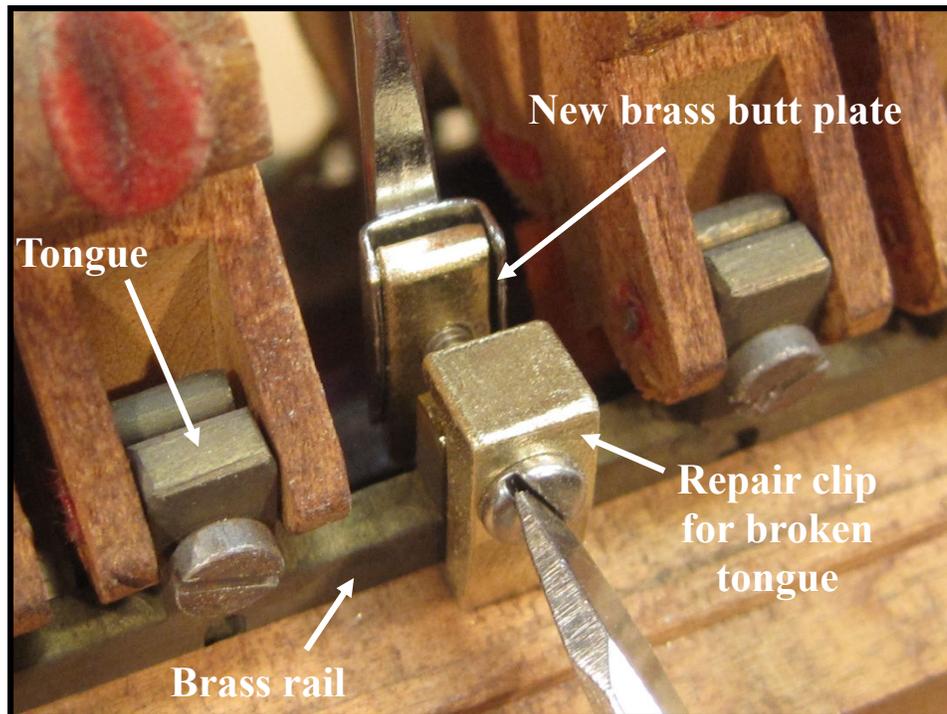
Repair being made to broken brass rail

Unfortunately, both the tongues of the brass rail itself and the brass butt plates are eventually susceptible to metal fatigue--although it often takes a century or so for problems to develop. Breakage is most likely to occur at the screw holes drilled into the brass butt plates and the tongues alike, and also at the channel in each tongue which allows room for the center pins. When a break does occur, the corresponding hammer butt no longer is held in check and the note will quit working, making repair work necessary (see photo above).

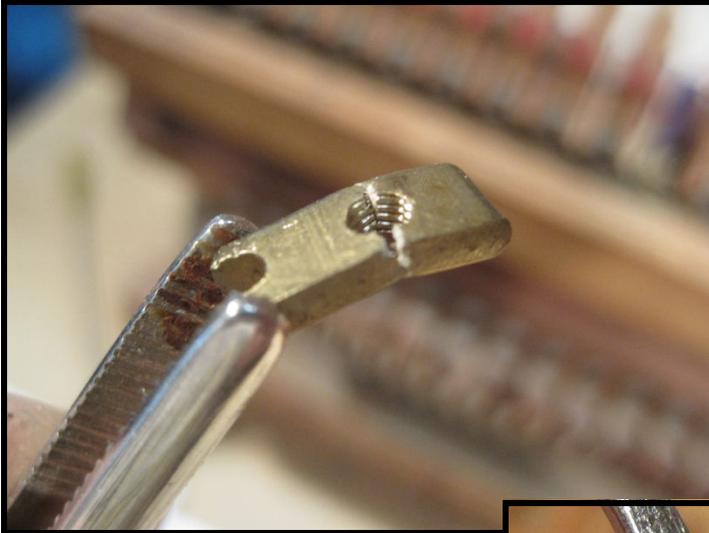
When a butt plate breaks, the break is nearly always in line with the threaded hole which is intended for a machine screw to affix the butt plate to a tongue of the brass rail. Typically, the break begins as a hairline crack (signaled by a loose or wobbly hammer assembly). When the break is complete, the hammer is no longer held in place.

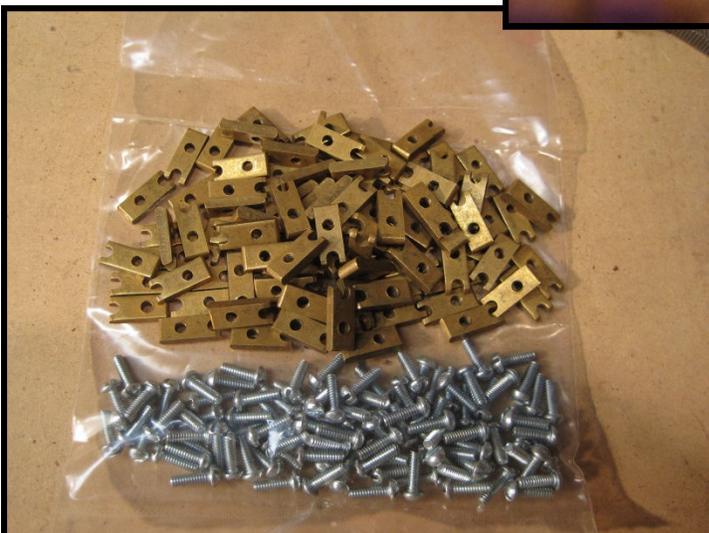
To insert a new butt plate (or plates), a special in-sertion tool is used to hold the small part in place while the machine screw is inserted through the tongue and into the plate. (Note: The action must be removed so that the replacement may be done from the back side of the action)

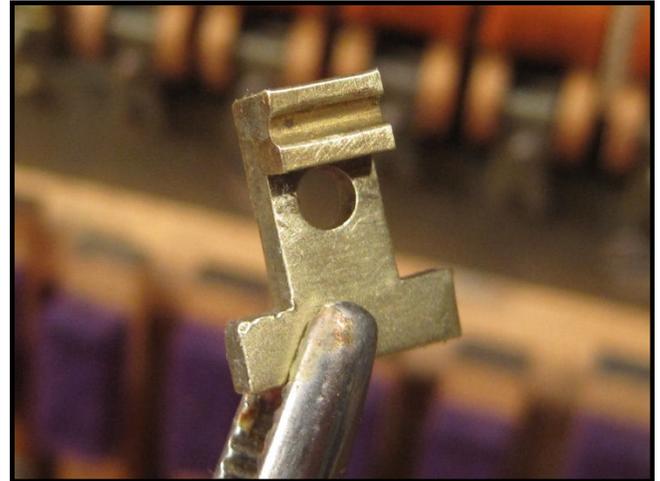
A special brass repair clip is used in this situation which replaces both sides of the channel. It also features a wider base for additional stability, since the original screw hole isn't completely intact.

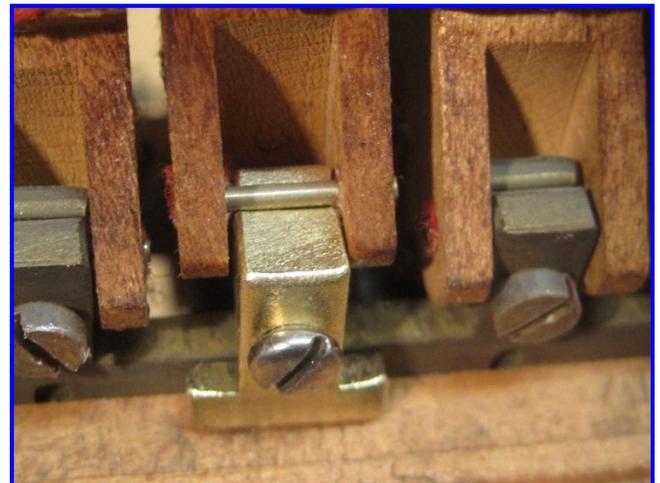
With the clip in place, and the screw inserted, a new butt plate is held in place with an insertion tool.

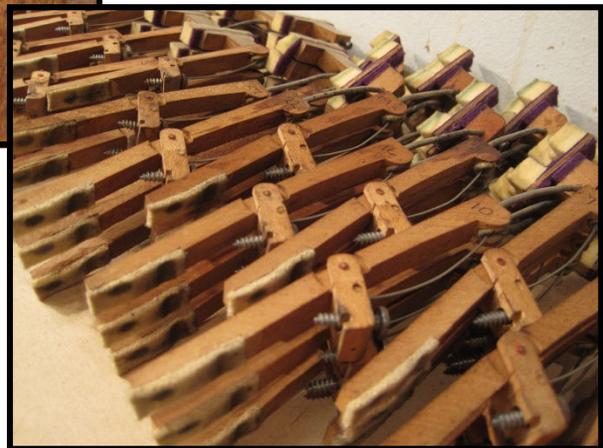
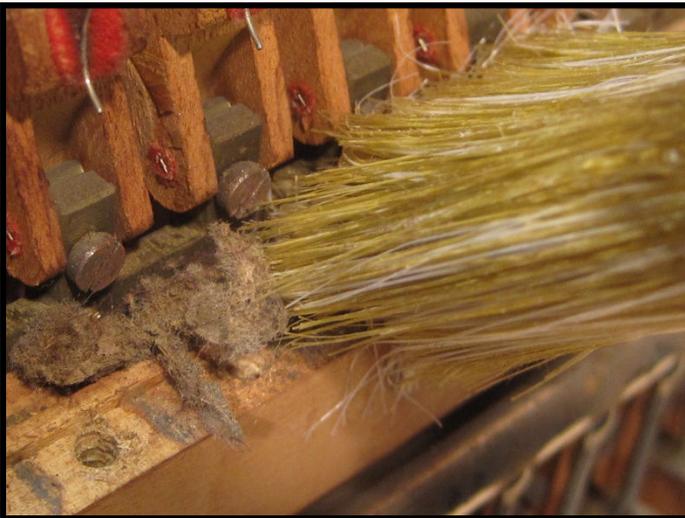
With the adjacent parts out of the way (right photo) and the accumulation of dust removed (below photo), the individual tongues and butt plates may be carefully inspected for hairline cracks.

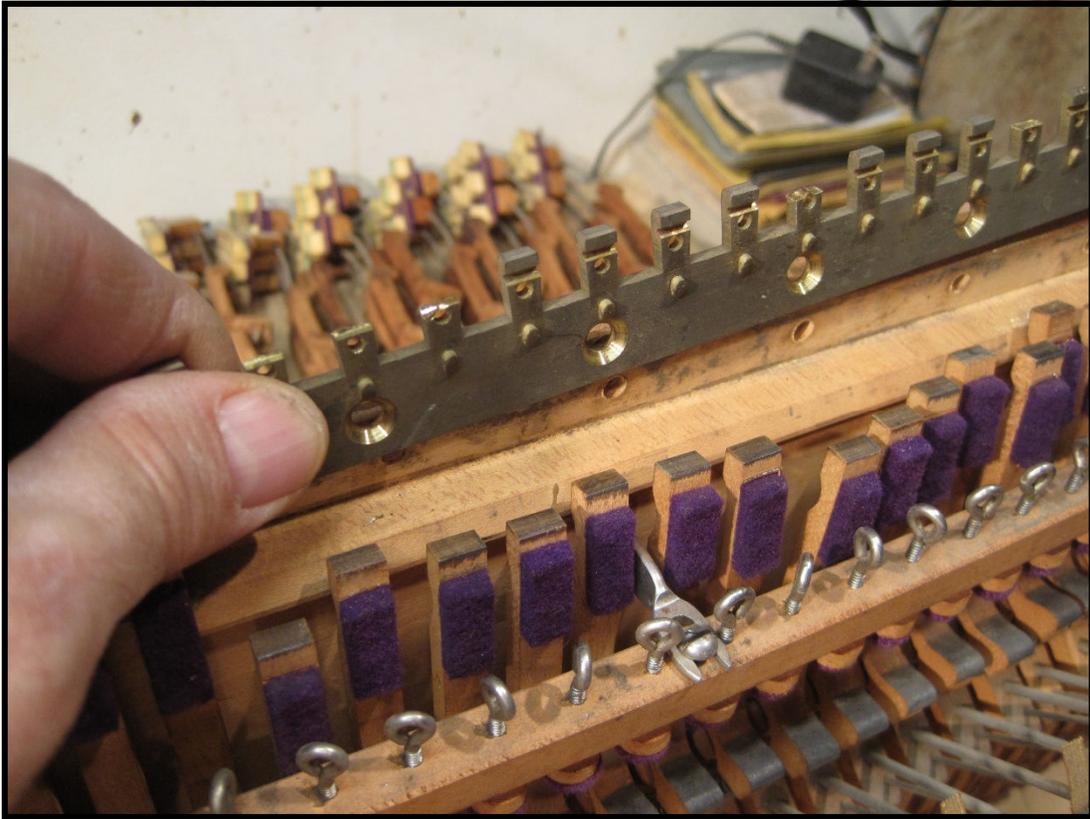
Brass rail with multiple problems being removed for duplication.

Note: If a number of tongues are broken, a more appropriate repair might be the duplication and replacement of the entire brass rail.
